**RCRA SITE SCREENING INSPECTION REPORT**  
**Enforcement Confidential – Deliberative Process**

SITE NAME: Canton Drop Forge  
EPA ID NUMBER: OHD004465142  
ADDRESS: 4575 Southway Street S.W.  
Canton, Ohio 44706  
DATE OF INSPECTION: July 1, 2011  
EPA INSPECTOR: Michael Beedle

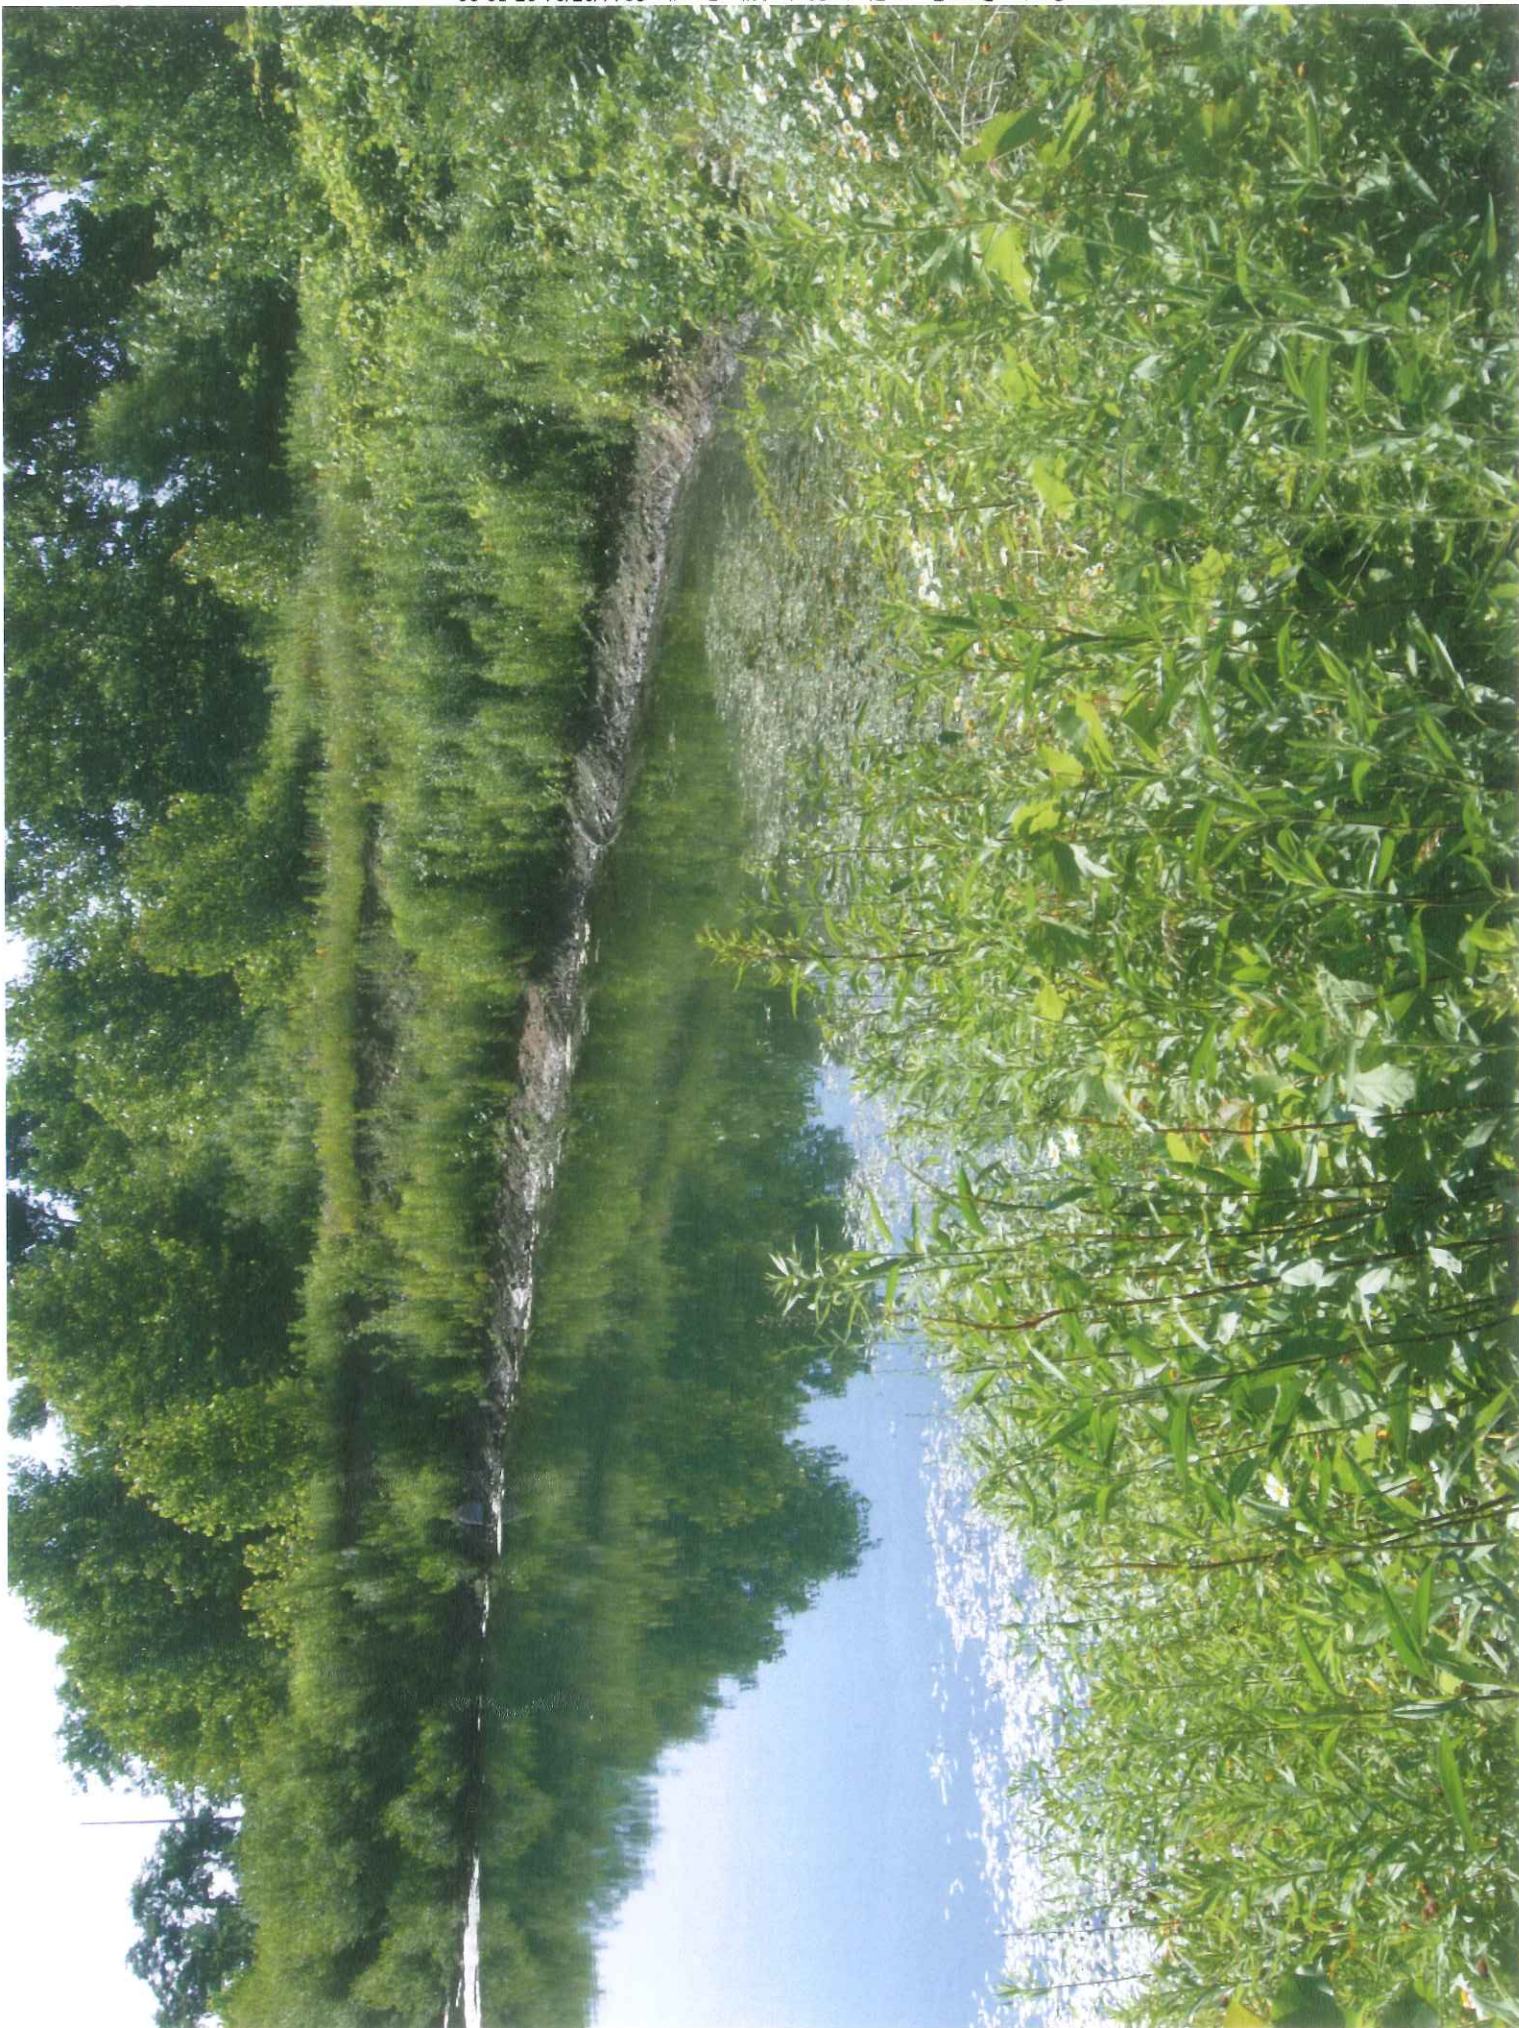
Canton Drop Forge Photo 29, by Mike Beedle, 2011/07/01 07:50:03

| Photo | Description |
|---|--|
| 29 | Pond 3, looking southeast. |

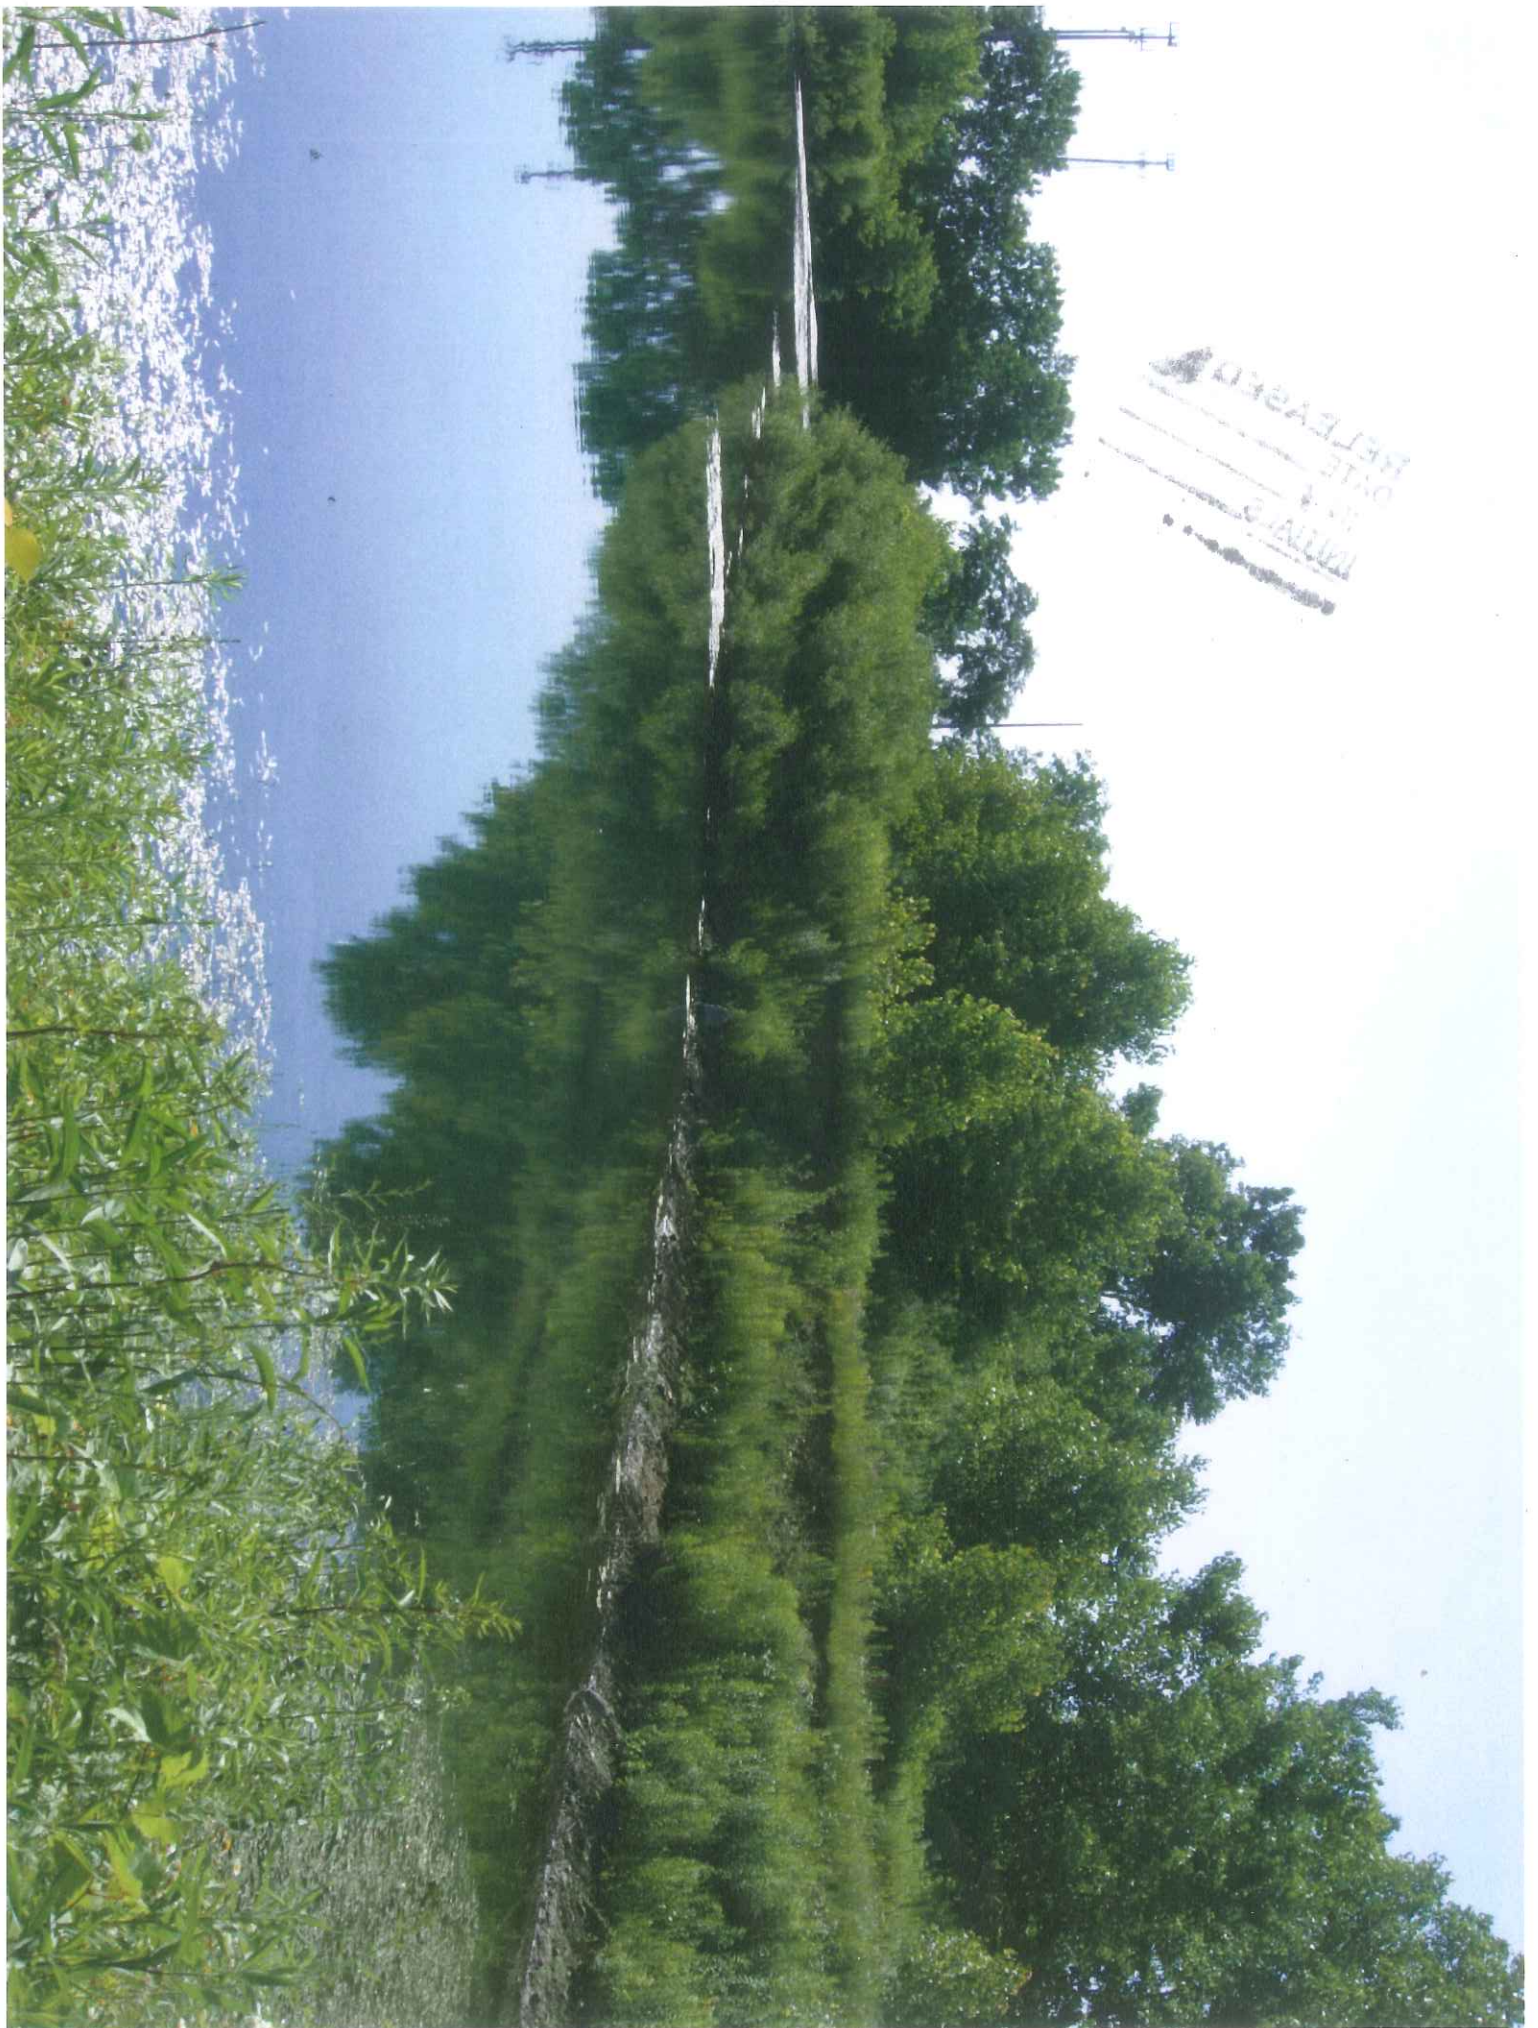
Canton Drop Forge Photo 30, by Mike Beedle ,2011/07/01 07:50:08

| Photo | Description |
|---|--|
| 30 | Pond 3, looking southeast. |
